THE BEST INSPECTOR PTY LTD

BUILDING & PEST INSPECTION COPY

30 Sample St
Sydney , NSW 2000

John Smith
08/08/2024

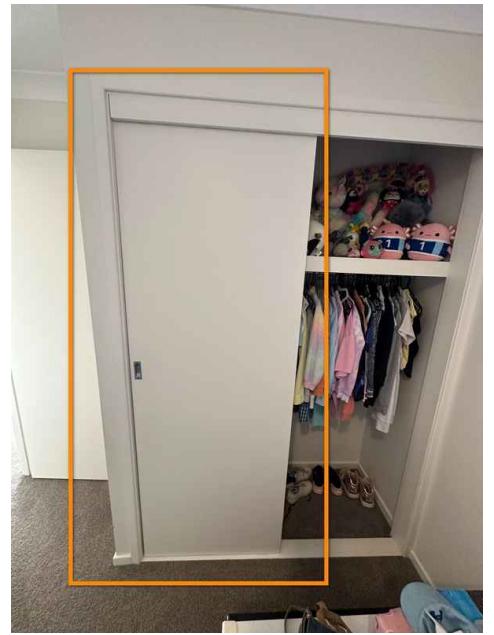
CUPBOARD DOOR

Minor Defect - Repair Needed

The cupboard requires general maintenance and possibly new rollers to function as indented.

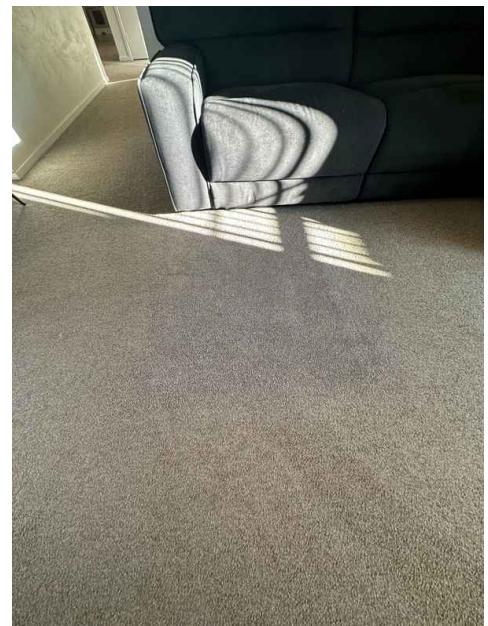
4.3.1 Floor

Minor Defect - Repair Needed

CARPET STAINS

The carpet had areas of staining or discolouration. Recommend a thorough steam cleaning by a qualified carpet cleaning company. If the stain/s remains new carpet may be required.

Contact a qualified cleaning service.

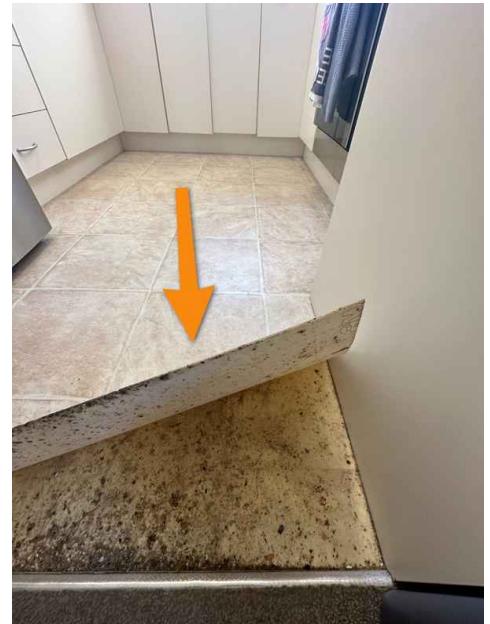
6.3.1 Floor

- Minor Defect - Repair Needed

LINO DETERIORATION

Lino Flooring has started to lift. Over time, linoleum flooring can deteriorate due to wear and tear, exposure to moisture, and heavy foot traffic. Signs of linoleum deterioration may include discolouration, peeling, and a spongy or uneven feel in certain areas. It's important to address linoleum deterioration promptly to prevent further damage and maintain the overall integrity of the flooring surface. Consulting a professional for assessment and repair.

Contact a qualified flooring contractor

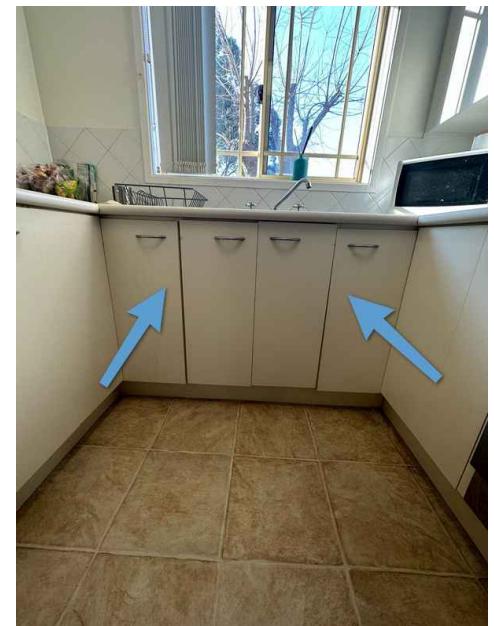
6.6.1 Cabinetry and Benchtops

ADJUSTMENT TO CABINET

Adjustment to cabinet doors is required for cabinet doors to sit flush. This may also require the replacement of hinges.

Contact a handyman or DIY project

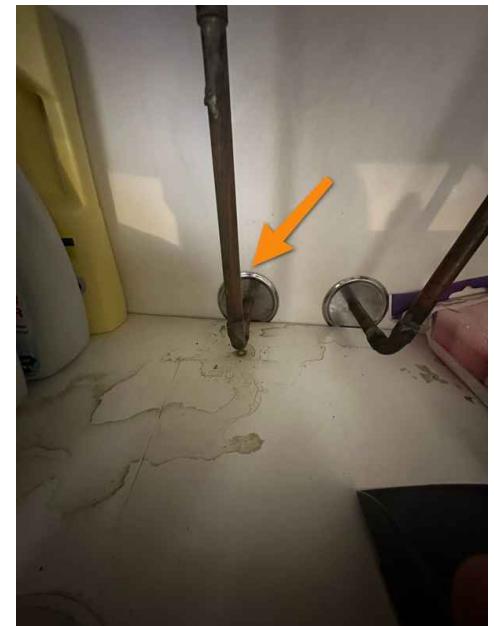
6.6.2 Cabinetry and Benchtops

LEAKING PIPE

Minor Defect - Repair Needed

A leaking Pipe was observed under the sink. It is important that this be repaired by a plumber asap to prevent any damage to surrounding materials.

Contact a qualified plumbing contractor.

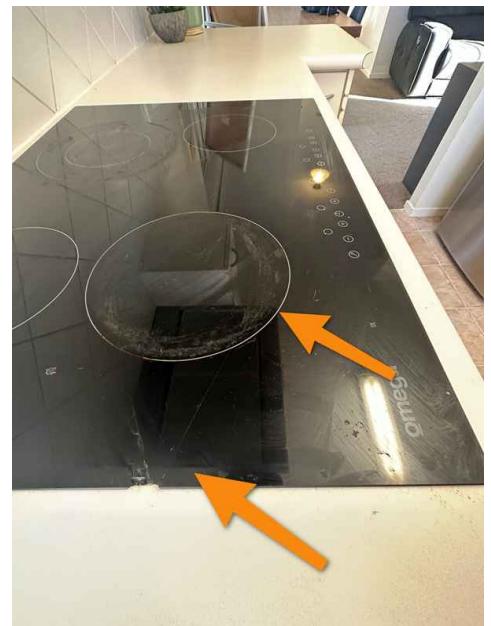
6.6.3 Cabinetry and Benchtops

Minor Defect - Repair Needed**DAMAGE COOK TOP**

Damaged Cook top observed. When a cooktop cracks, it compromises the surface's integrity and may pose safety risks, such as sharp edges or potential electrical hazards if it's an induction or electric model. Immediate attention is necessary to prevent further damage and ensure safe cooking conditions. Replacing the cracked cooktop is essential.

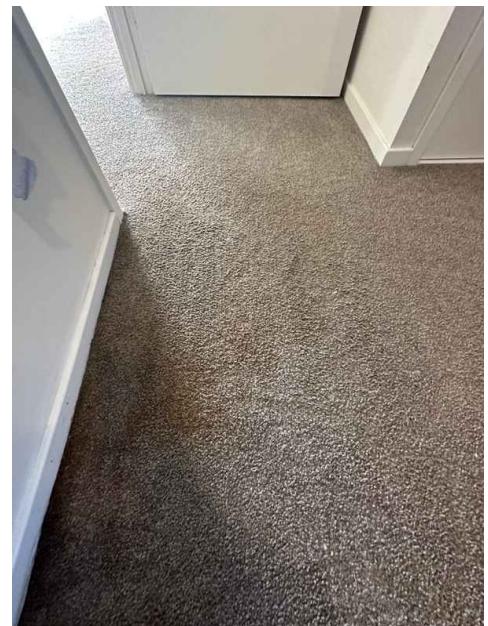
9.3.1 Floor

Minor Defect - Repair Needed

CARPET STAINS

The carpet had areas of staining or discolouration. Recommend a thorough steam cleaning by a qualified carpet cleaning company. If the stain/s remains new carpet may be required.

Contact a qualified cleaning service.

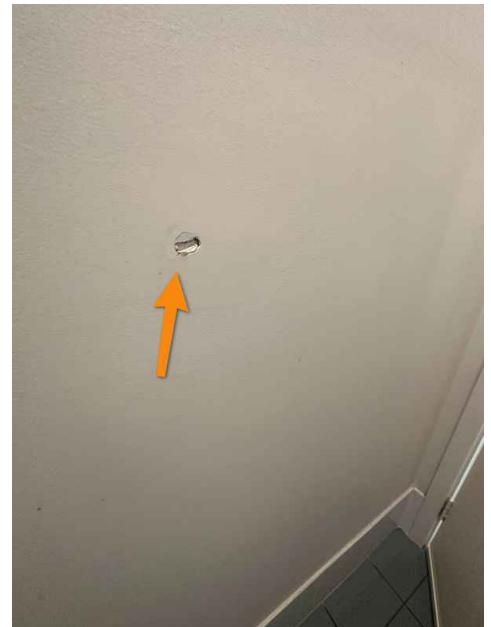
11.4.1 Walls

Minor Defect - Repair Needed

IMPACT DAMAGE

Impact damage has been observed, advise that a plaster contractor be engaged for repairs.

The door handle has damaged the wall. I advise a door stop be added after the wall is patched and painted.

Contact a qualified gyprock contractor

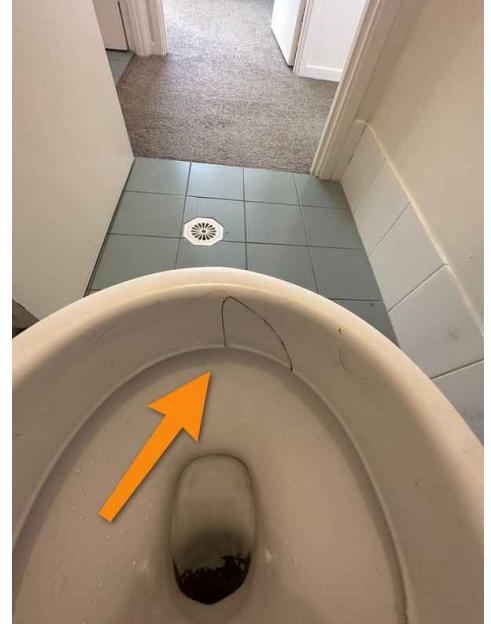
Minor Defect - Repair Needed

DAMAGE

Toilet appears to be damaged and requires repairs. Contact a plumber for assessment.

Contact a qualified plumbing contractor.

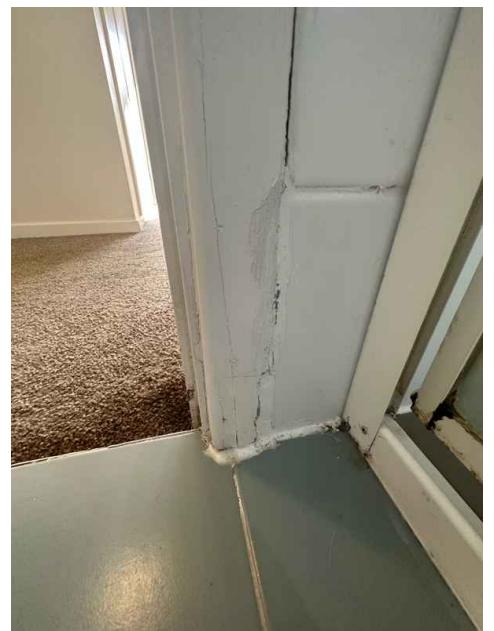
12.1.1 Doors

WATER DAMAGE

Water damage to the base of a timber door frame in the bathroom typically results from persistent moisture exposure, often due to poor ventilation, leaks, or splashing. This damage can cause the timber to swell, warp, or deteriorate, which can compromise the door frame's integrity and appearance. The problem appears to have been fairly poorly repaired and should be monitored during heavy use.

- Minor Defect - Repair Needed

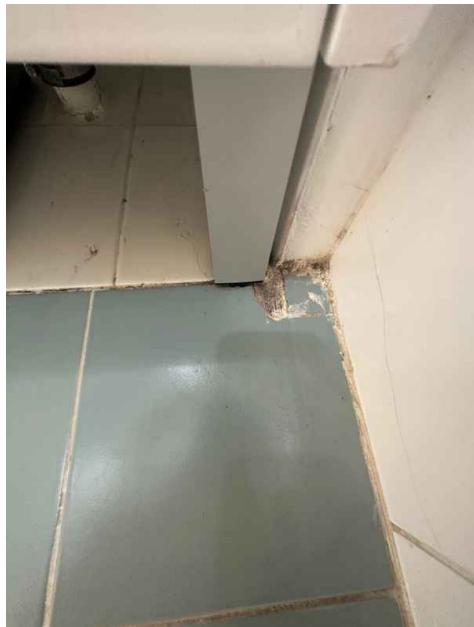
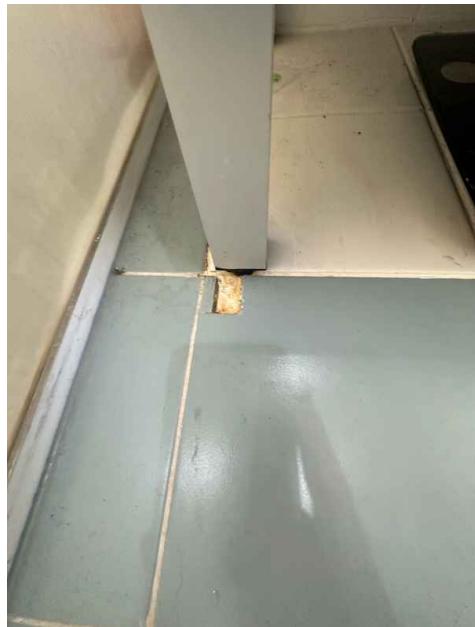
12.3.1 Floor

CRACKED TILE/S

Cracked or chipped floor tiles have been observed. I advise a tiler to be contacted for repairs.

Minor Defect - Repair Needed

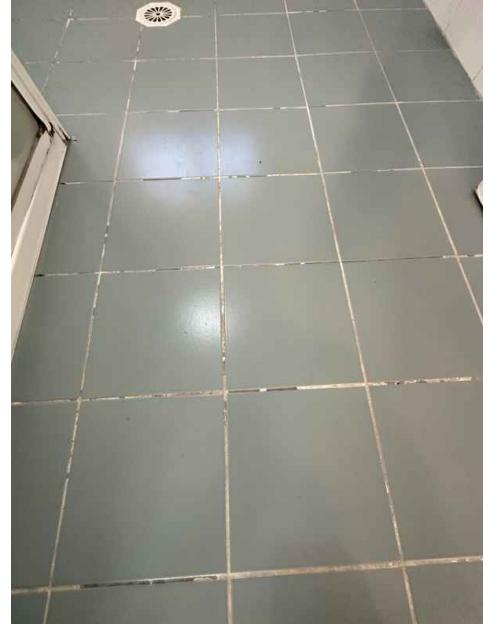
12.3.2 Floor

GROUT DETERIORATION

Minor Defect - Repair Needed

Tile grout has deteriorated and should be repaired by a qualified tiler.

Contact a qualified tile contractor

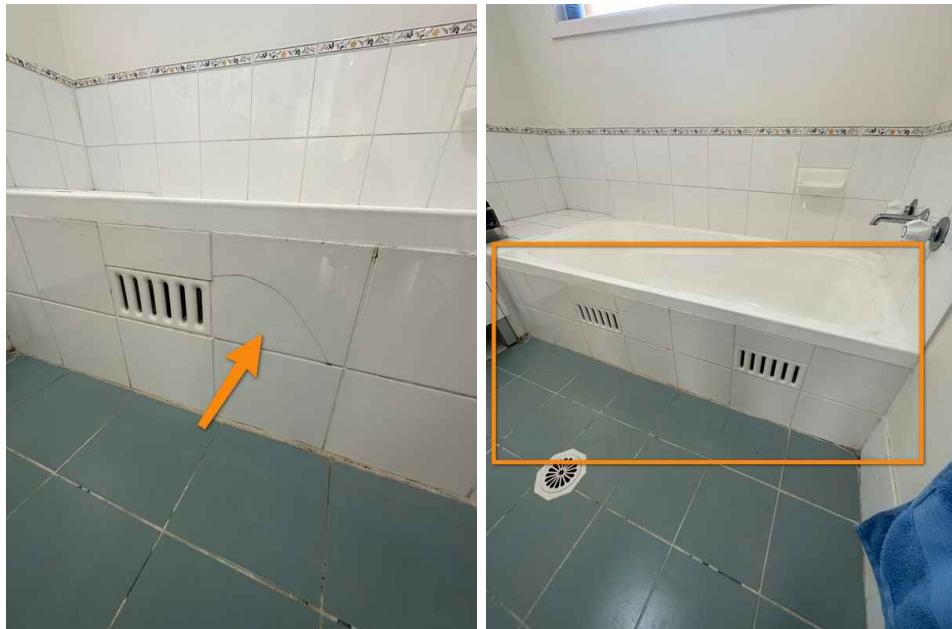
12.8.1 Shower & Bath

CRACKED TILE/S

Cracked/deteriorated tiles were observed during the inspection. It is recommended to consult with a plumber to assess and rectify. Replacement of the affected tiles is advised to restore the integrity and aesthetics of the area.

Minor Defect - Repair Needed

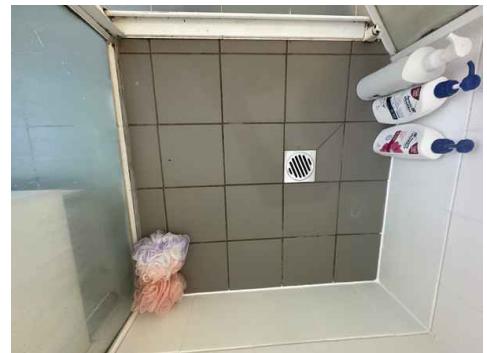
12.8.2 Shower & Bath

GROUT DETERIORATION

Minor Defect - Repair Needed

Contact a qualified plumbing contractor.

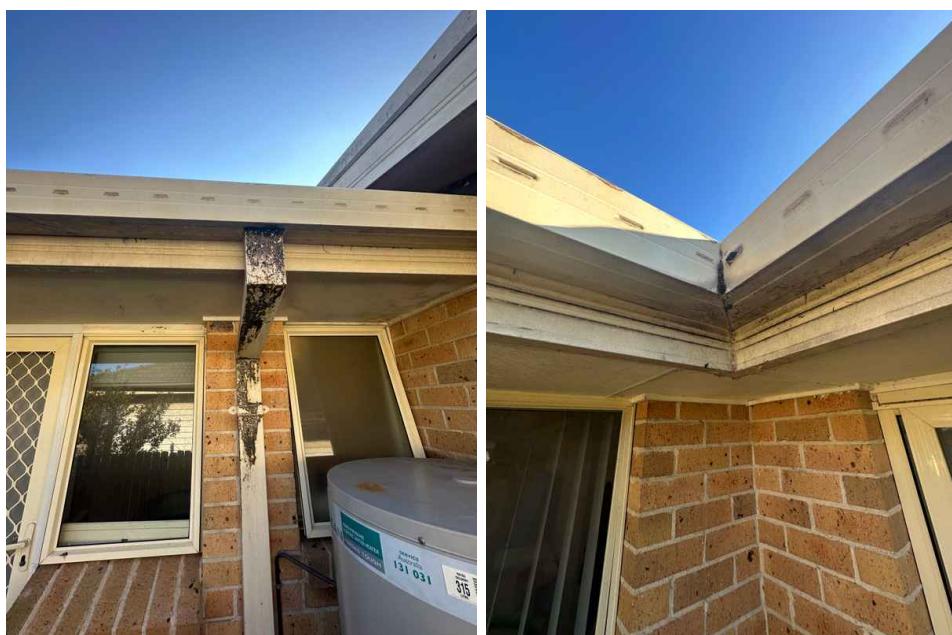
14.3.2 Drainage Systems

GUTTER LEAKAGE

Contact a qualified roofing professional.

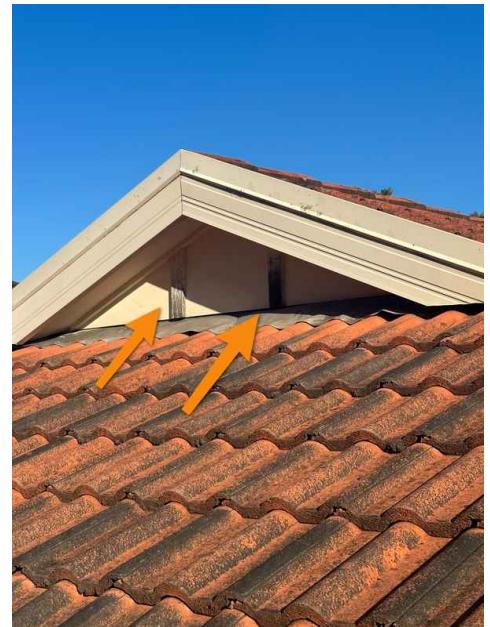
15.2.4 Eaves, Soffits & Fascia

PAINT/FINISH FAILING

Contact a qualified painting contractor.

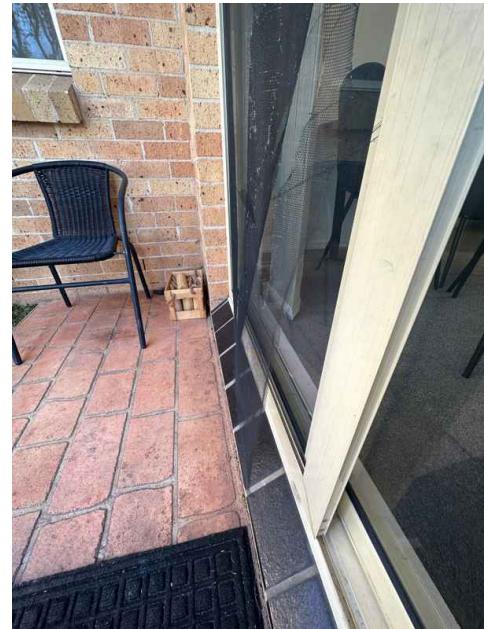
15.3.1 Entries & Exterior Doors

DAMAGED FLY SCREEN

Minor Defect - Repair Needed

The fly screen on the external door is damaged. It should be repaired or replaced to keep insects out and ensure the door works properly.

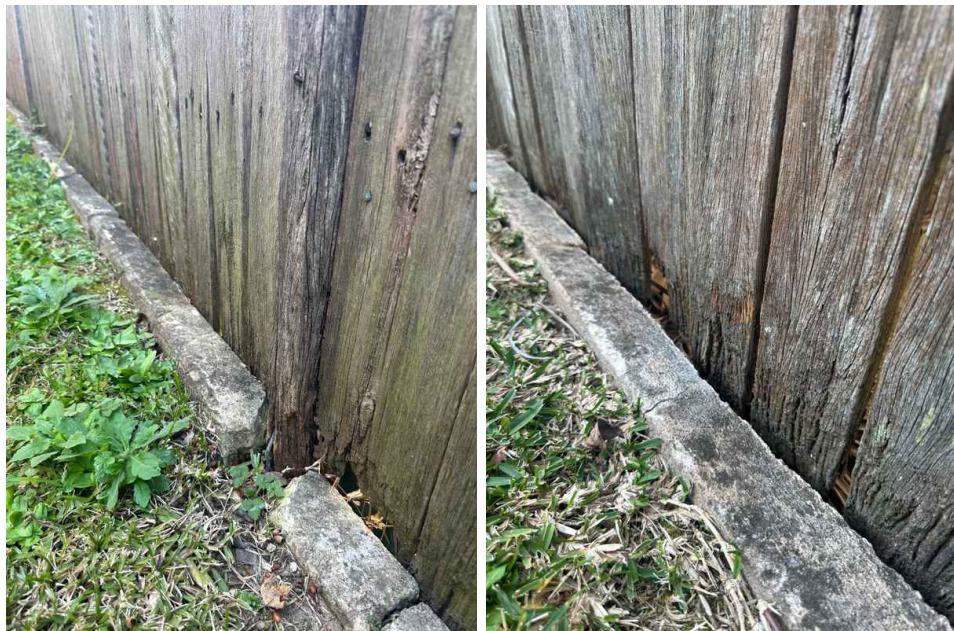
15.5.3 Fences/Gates

WOOD ROT

Minor Defect - Repair Needed

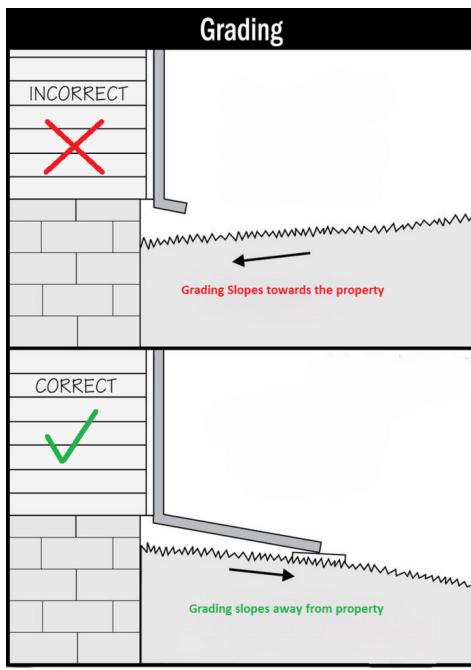
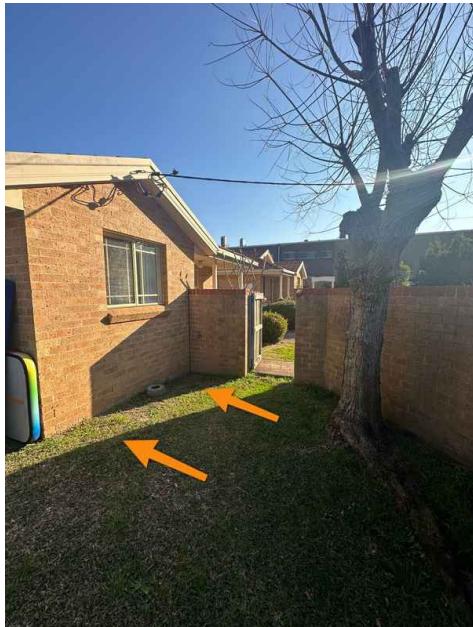
15.6.1 Gardens & Drainage

NEGATIVE GRADING

Contact a qualified landscaping contractor

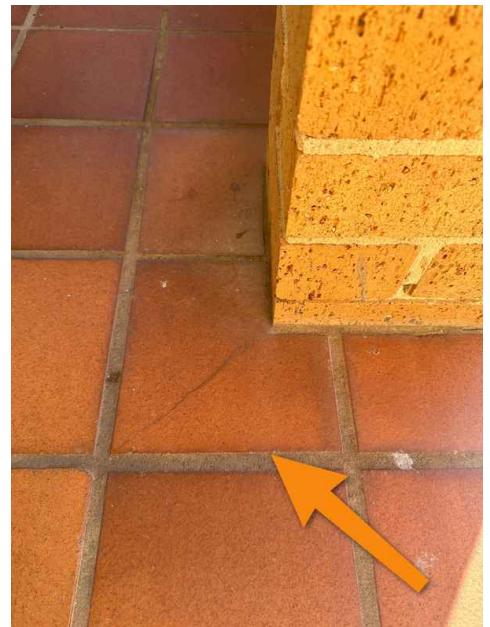
15.7.1 Verandah & Patio

DAMAGED TILE/S

Minor Defect - Repair Needed

Contact a qualified tile contractor

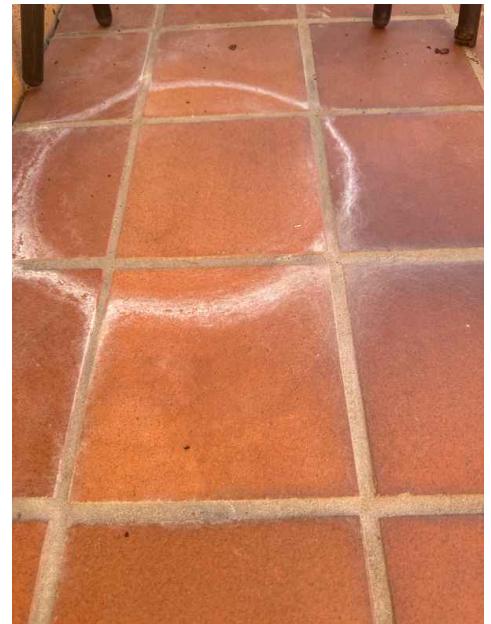
15.7.2 Verandah & Patio

**STAIN**

Stain was observed on the tile. Cleaning advised
